Manhole Inspection Summary

Manhole # S25K__021MH

Location Address: **351 Ramsay St**

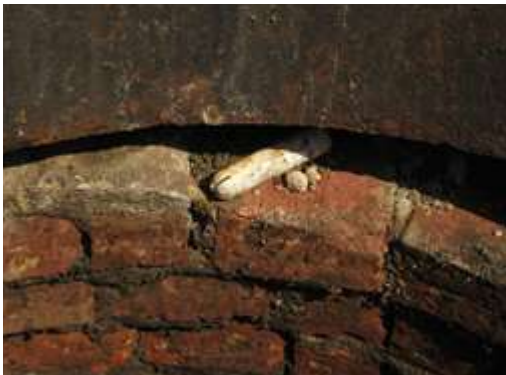
Defect 2

Surcharge ☒ **Evidence Of Surcharge** Depth: **13** (ft.) ☐ Active Surcharge Present

evidence of surcharge

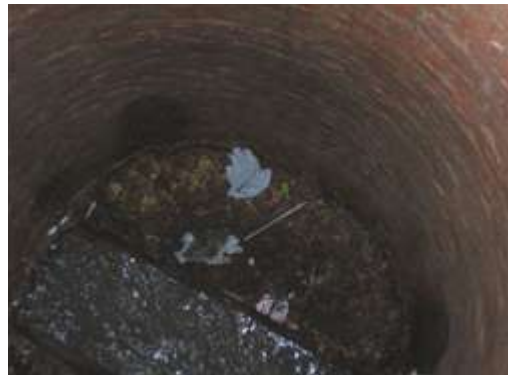
Defect 3

evidence of surcharge

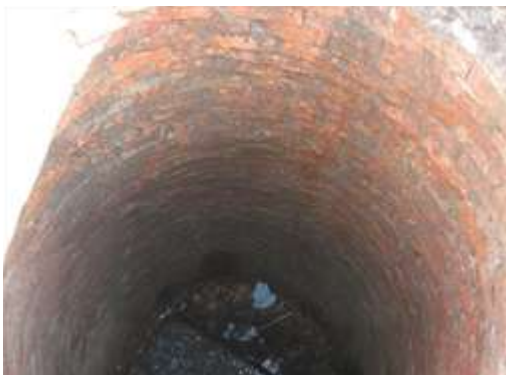
Defect 4

Condition: ☐ Sound ☐ Cracked ☐ Root Intrusion ☐ Deteriorated ☐ Leaks ☒ **Debris**

Debris on bench

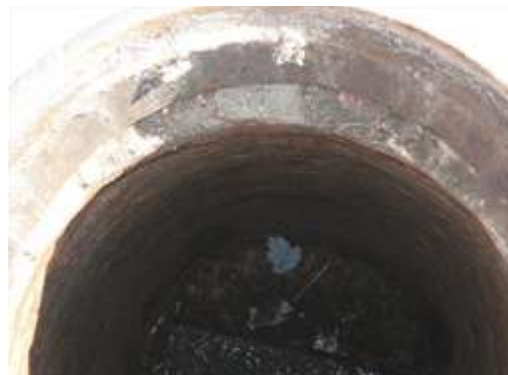
Defect 1

Infiltration: ☐ None ☐ Joint ☐ Cracks ☐ Mortar ☐ Roots ☒ **Wall**

infiltration along entire walls

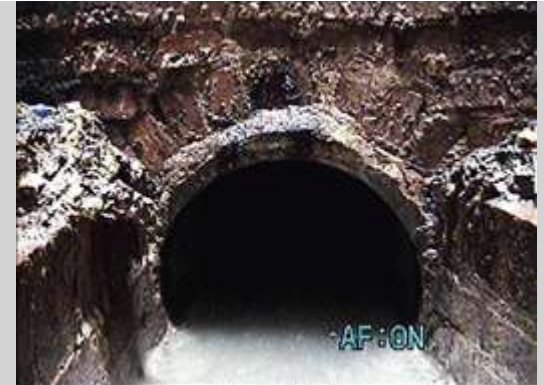
12 O'Clock Outflow

15 in. Circular Gravity Sewer
Pipe Out @ 12 O'Clock

Pipe Height: **15.6** (in.) Rod and Bar (Angled)
Pipe Material: **Clay** ☐ Pipe Lined
Invert Depth: **14.78** (ft.) Flow Characteristics: **Fast**
Deposits: ☒ None ☐ Mud ☐ Sludge ☐ Debris ☐ Grease
Silt Depth: **0** (in.) Deposits Extent:
Infiltration: **None** Pipe Seal Cond: **Sound**

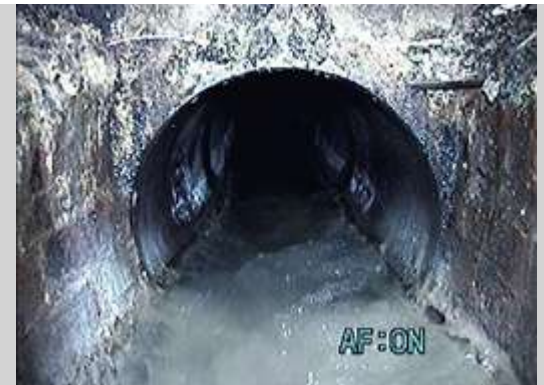
6 O'Clock Inflow

15 in. Circular Gravity Sewer
Pipe In @ 6 O'Clock

Pipe Height: **15.6** (in.) Rod and Bar (Angled)
Pipe Material: **Clay** ☐ Pipe Lined
Invert Depth: **14.76** (ft.) Flow Characteristics: **Fast**
Deposits: ☒ None ☐ Mud ☐ Sludge ☐ Debris ☐ Grease
Silt Depth: **0** (in.) Deposits Extent:
Infiltration: **None** Pipe Seal Cond: **Sound**
